RESEARCH REPORT

Durability static test of a gyrocopter hub bar

Report No: LM1/RPT/Gyrotech/01/18

<i>Durability test of a gyrocopter hub bar type GT/HB/AL2017</i>	<i>Report no.</i> LM1/RPT/Gyrotech/01/18
		ISSUE : I

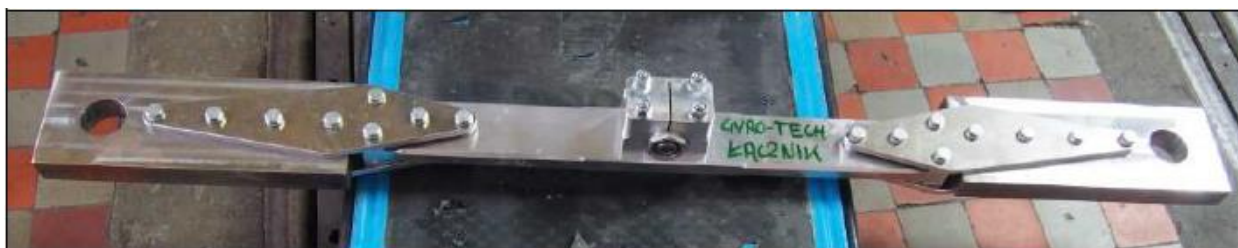
The object of the study was a set of hub bar for gyrocopter blades, type GT/HB/AL2017. Elements for implementing loads were designed and made by the Principal.

Pic 1. Hub bar type **GT/HB/AL2017**

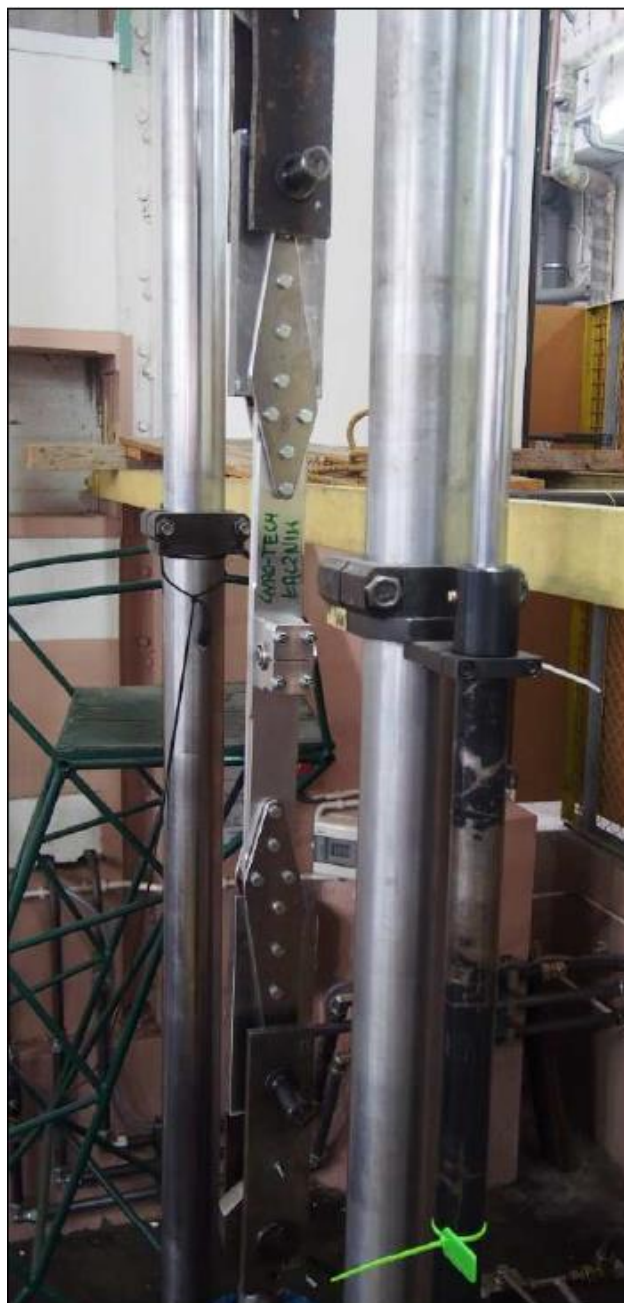
Hub bar – GT/HB/AL2017

Pic. 2 Hub bar mounted on the testing station

The tests were carried out on the AVIATA durability frame equipped with suitable facilities, allowing adding required loads to the tested element.

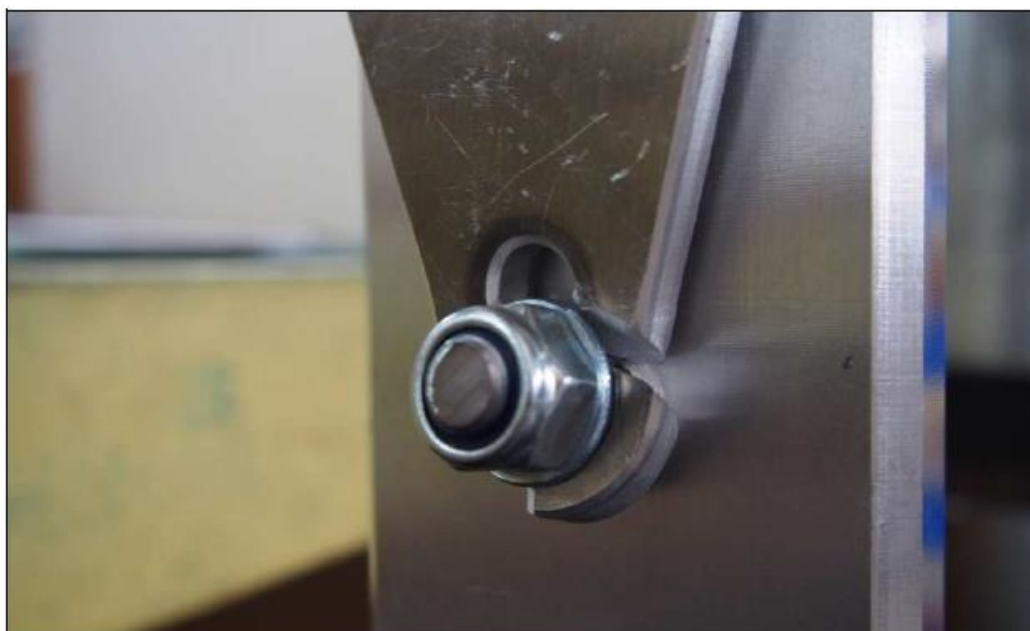
Form of destruction: shear of bolts at connection implementing the load.

Pic. 4. Destroyed bolts connection in the hub bar

The course of force against displacement is presented in the chart – Fig. 1, while the form of destruction is presented in Pic.3 and 4.
